THE EFFECT OF RESIDUAL STRESS ON CRACK PROPAGATION IN HY-80 STEELS

INTERIM REPORT
Contract Number N00014-70-C-0265
SwRI Project 03-2801

for
Office of Naval Research
Department of the Navy
Washington, D. C. 20360

October 22, 1971

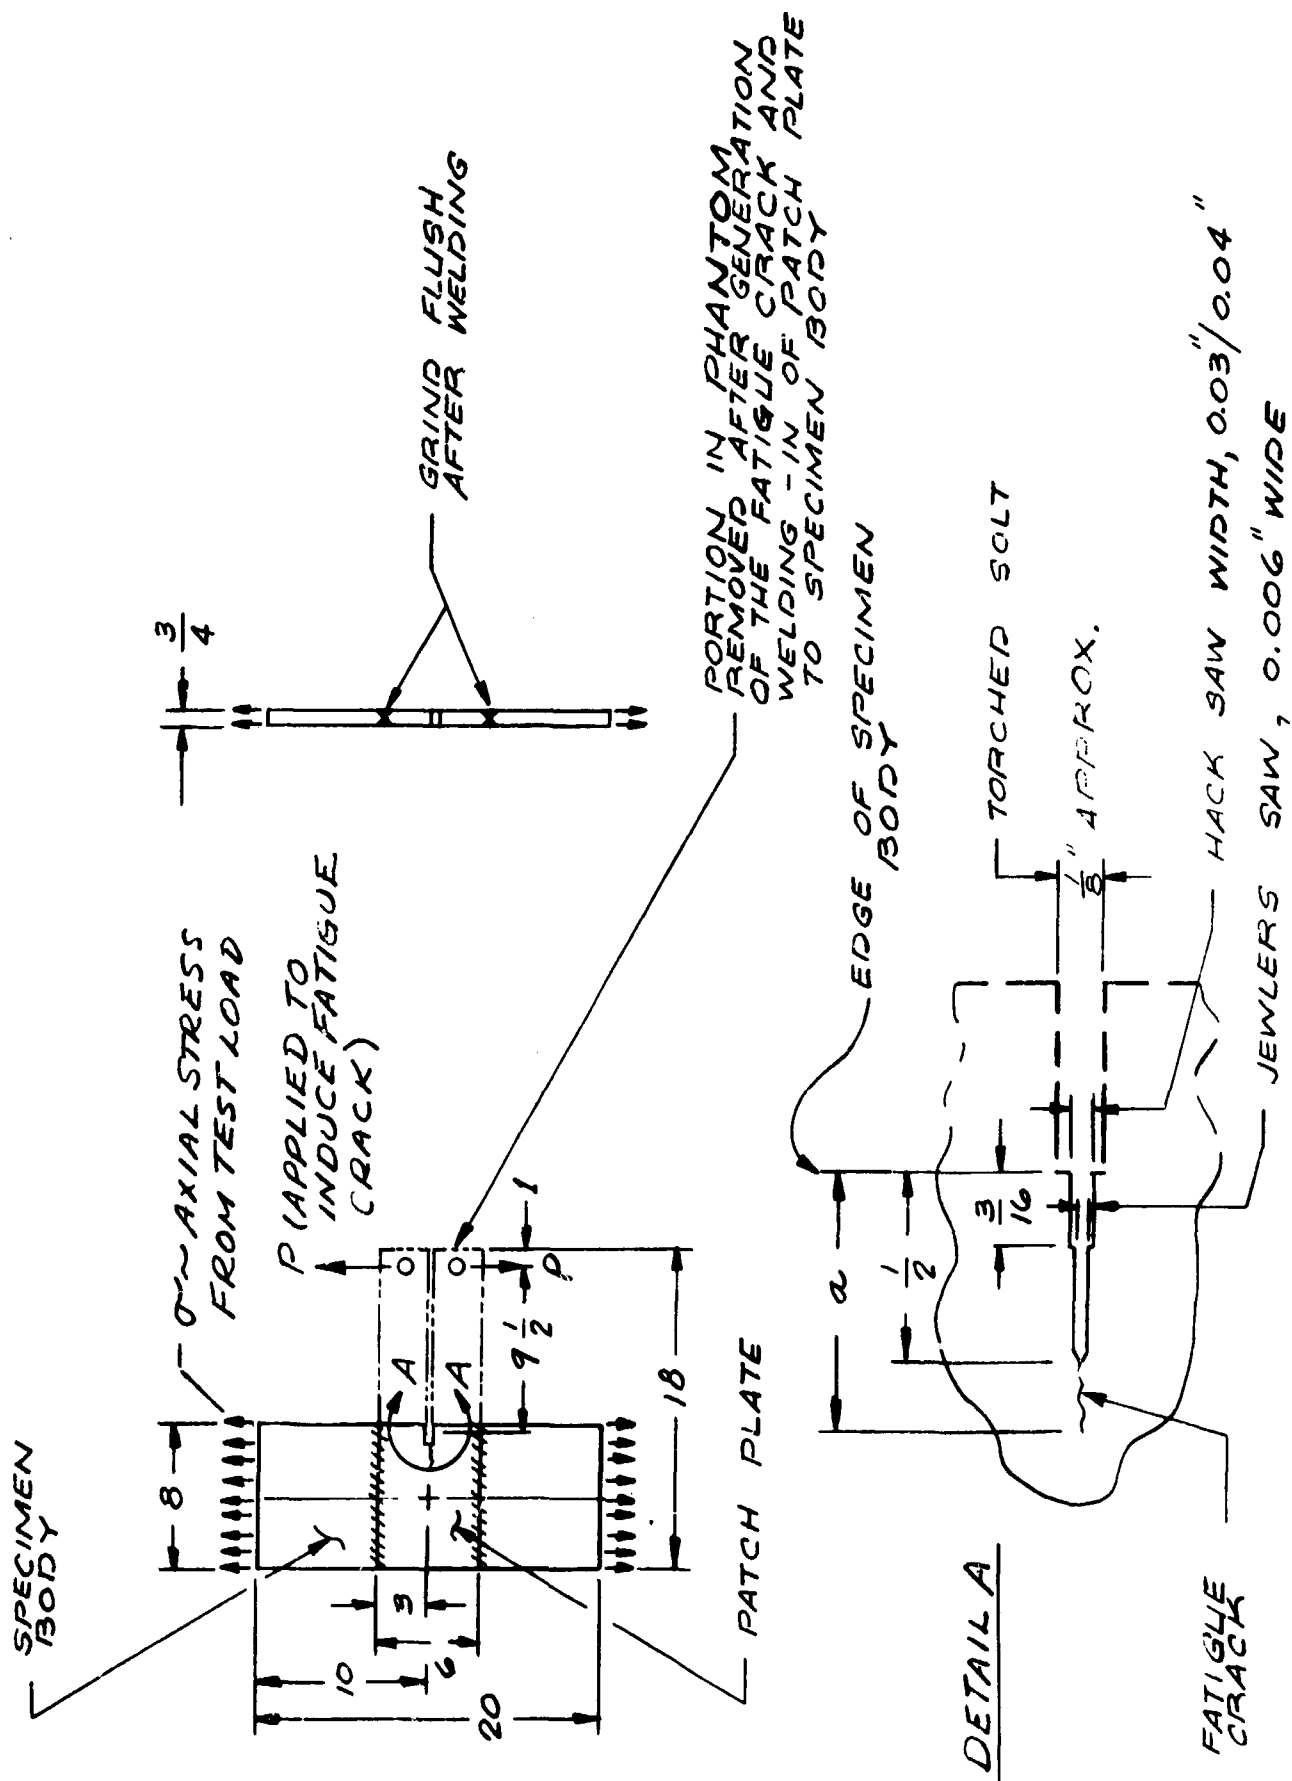
FIGURE 3. SPECIMEN CONFIGURATION "A"

The specimen was fabricated by introducing, into a patch plate, a fatigue crack at the tip of a torched plus saw-sharpened slot; the patch plate was then welded into the specimen body. This is shown in Figures 3 and 4. Therein, it will be noted that in the "A" configuration patch, a stress near the crack tip will not be induced as a result of cooling - and accompanying shrinkage - of the weld because no restraint is offered by the specimen geometry; in the "B" configuration, however, restraint is offered by the specimen body and, as cooling progresses, tensile stresses are induced across the patch, normal to the fatigue crack.

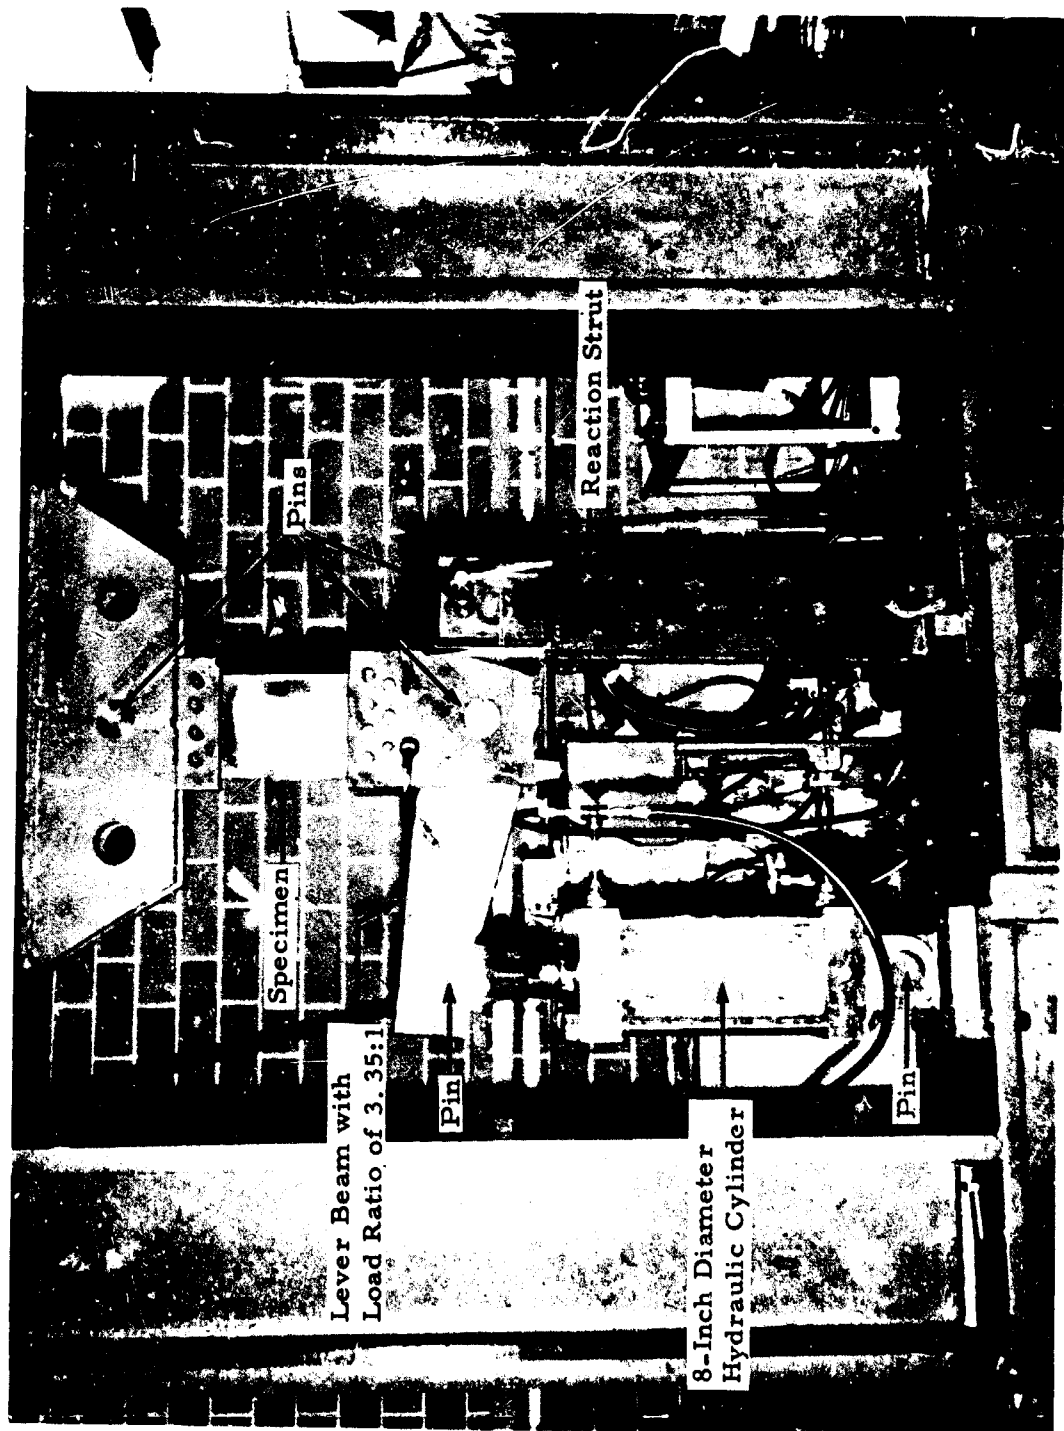
FIGURE 5. THE LOADING FRAME WITH SPECIMEN INSTALLED

After initiation and propagation of the fatigue crack into the patch plate for a distance of 1/2-inch approximately, strain gages with axes parallel to the specimen axis were affixed on both sides of the specimen, adjacent to the crack tip. These gages served a dual purpose in that they were used to monitor strains induced by welding and, also, to detect any tendency for transverse bending due to side-to-side eccentricity of the later applied load. Because of the proximity of the gages to the weld area, Micro-Measurements, Inc. high temperature type gages were used. The instrumented specimen was then mounted in the loading frame shown in the photograph, Figure 5. This loading fixture incorporated an 8-inch diameter hydraulic cylinder attached to a lever beam which had a mechanical advantage of 3.35:1. As all joints were pinned, (see Figure 5), the

specimen was loaded as a two force member even though the lever beam and pin traveled in a circular arc.

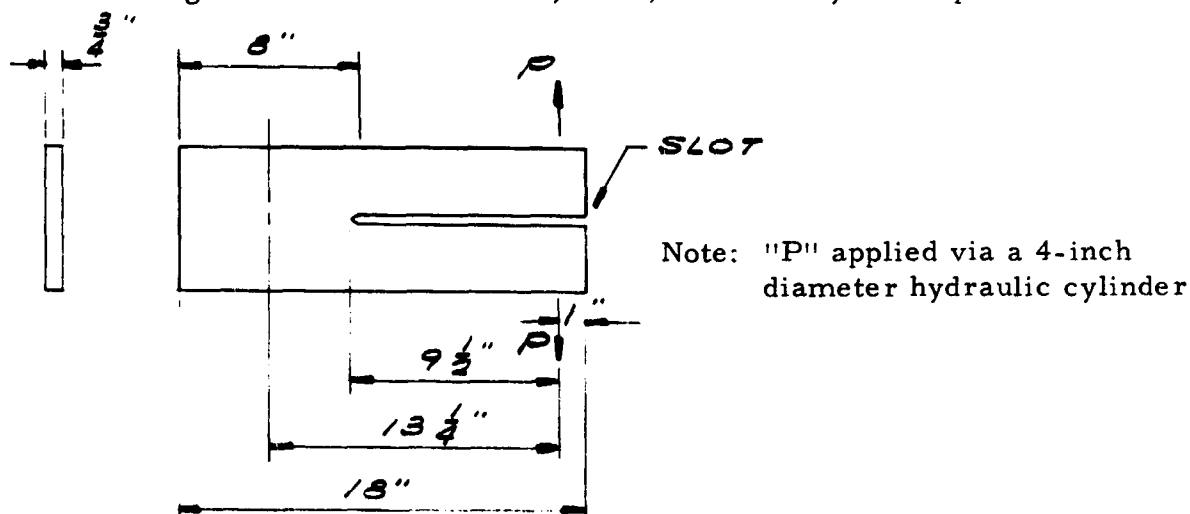
As mentioned in the previous section, a fatigue crack was generated in a patch plate by means of a load applied via a hydraulic cylinder. As is shown below, these results, in themselves, provide useful information as to crack growth rates. Consider, first, a free body of the patch:

Initially, the cylinder was pressurized to 750 psi which induced a load of 7,620 lbs; stress normal to the tip of the saw cut then becomes:

$$\sigma = \frac{6M}{bt^2} + \frac{P}{A} = \frac{(6)(7620)(13.25)}{(3/4)(7.5)^2} + \frac{7620}{(3/4)(7.5)} = 15,725 \text{ psi}$$

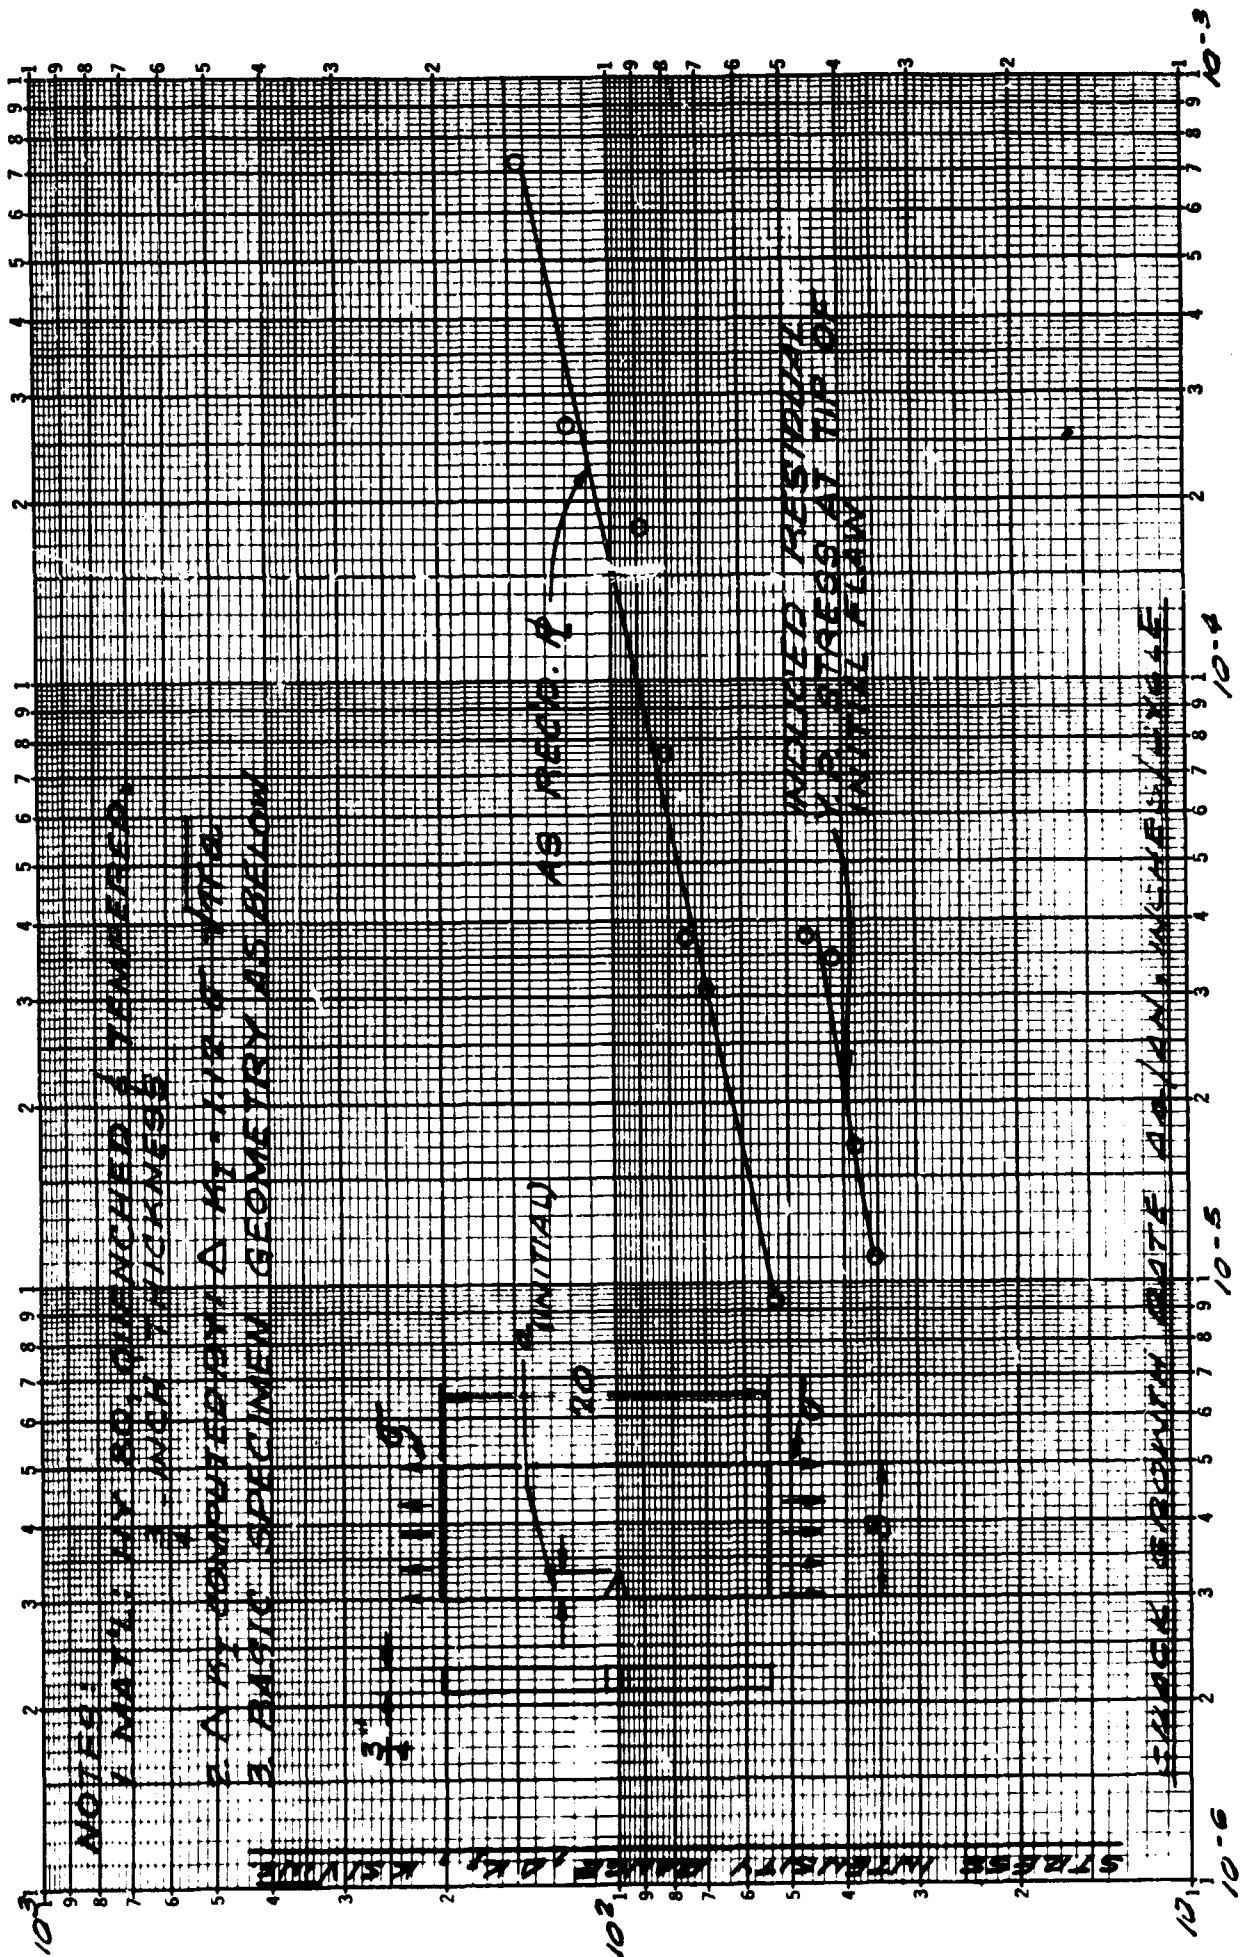
FIGURE 6. CRACK GROWTH RATE VS STRESS INTENSITY RANGE -
HY-80 STEEL

The results of the tests conducted in this investigation indicate that, as might be expected for a given stress intensity range, crack growth rate is accelerated by the presence of high residual stresses normal to the tip of a fatigue crack. The equation for the rate of growth may be determined from the data of Figure 6. Therein:

The latter, by inspection, results in the faster growth rate for any significant value of ΔK .

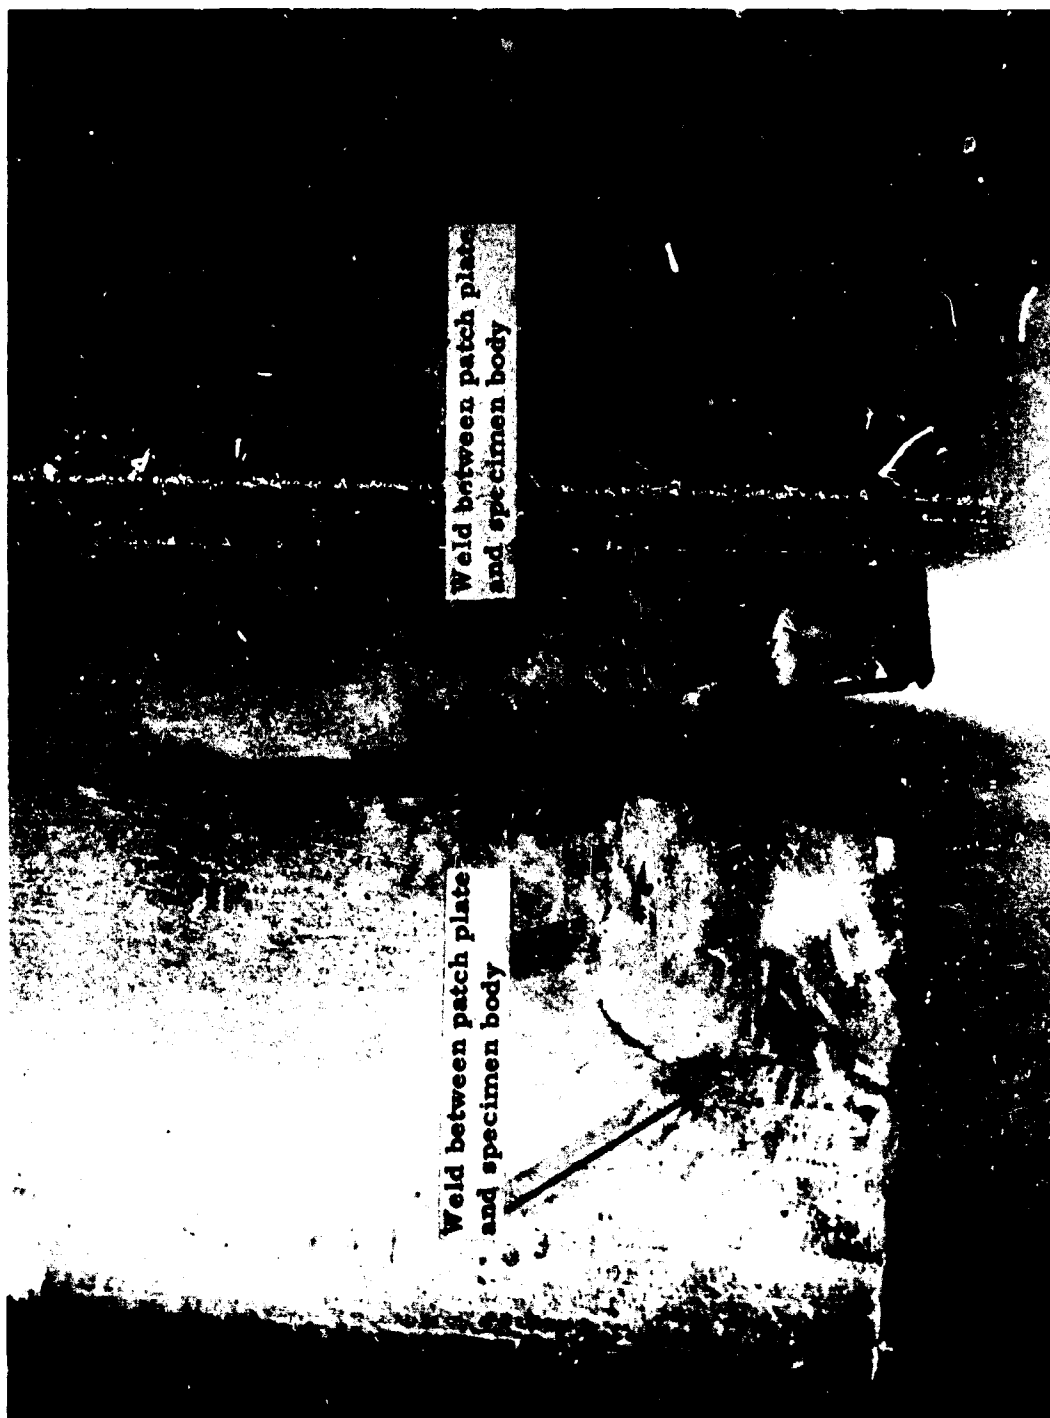
FIGURE 8. FINAL FAILURE OF A SPECIMEN WITH WELD-INDUCED Y. P.
RESIDUAL STRESSES ACROSS THE FATIGUE CRACK TIP
